CHAPTER 17 SURGICAL THERAPY FOR DEEP VALVE INCOMPETENCE

Original author: Seshadri Raju
Abstracted by Gary W. Lemmon

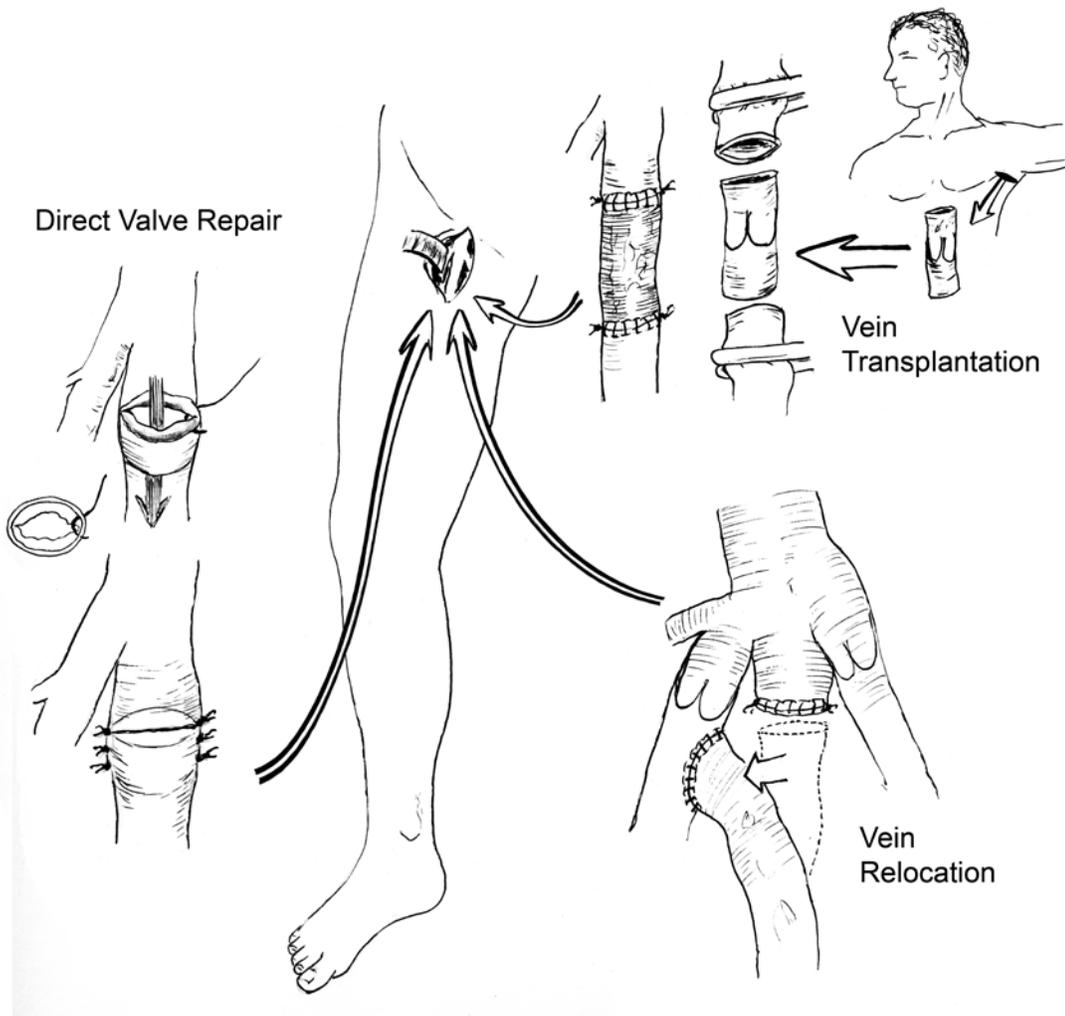
Figure 1: The artist has drawn pictures that show different ways of surgically placing a work valve in the lower leg deep veins to prevent problems with deep venous reflux. The picture of the leg shows a cut in the groin in many of these veins repairs are preformed. The picture to the left of the leg shows a direct repair of a floppy valve using very fine sutures to tighten the valve edges and make it work again (direct valve repair). The picture in the upper right shows taking a working valve from the arm and sewing it into the lower leg deep vein to prevent reflux in that system (vein transplantation). The picture in the bottom right shows placement of the non-working or incompetent major vein below a working valve in another part of the lower leg deep veins (vein relocation or transposition).

Axillary vein valve transfer (Figure 1) originally described by Dr. Raju in 1981 is used when **direct vein valve repair** or **vein relocation** is not possible. The **axillary veins** near the armpit are of similar size to the **femoral veins** in the thigh. A segment of **vein** with a good functioning **valve** is taken from the arm **veins** through a small incision in the armpit. This **valve** segment is then placed into the lower leg **incompetent vein** system by suturing it to both ends of the cut deep leg **vein**. Occasionally a plastic cover is placed over the **valve repair** site to prevent late **vein** dilation.
