CHAPTER 18

ILIAC AND VENA CAVA OBSTRUCTIVE VENOUS DISEASE THERAPY

Original author: Peter Neglén
Abstracted by Gary W. Lemmon

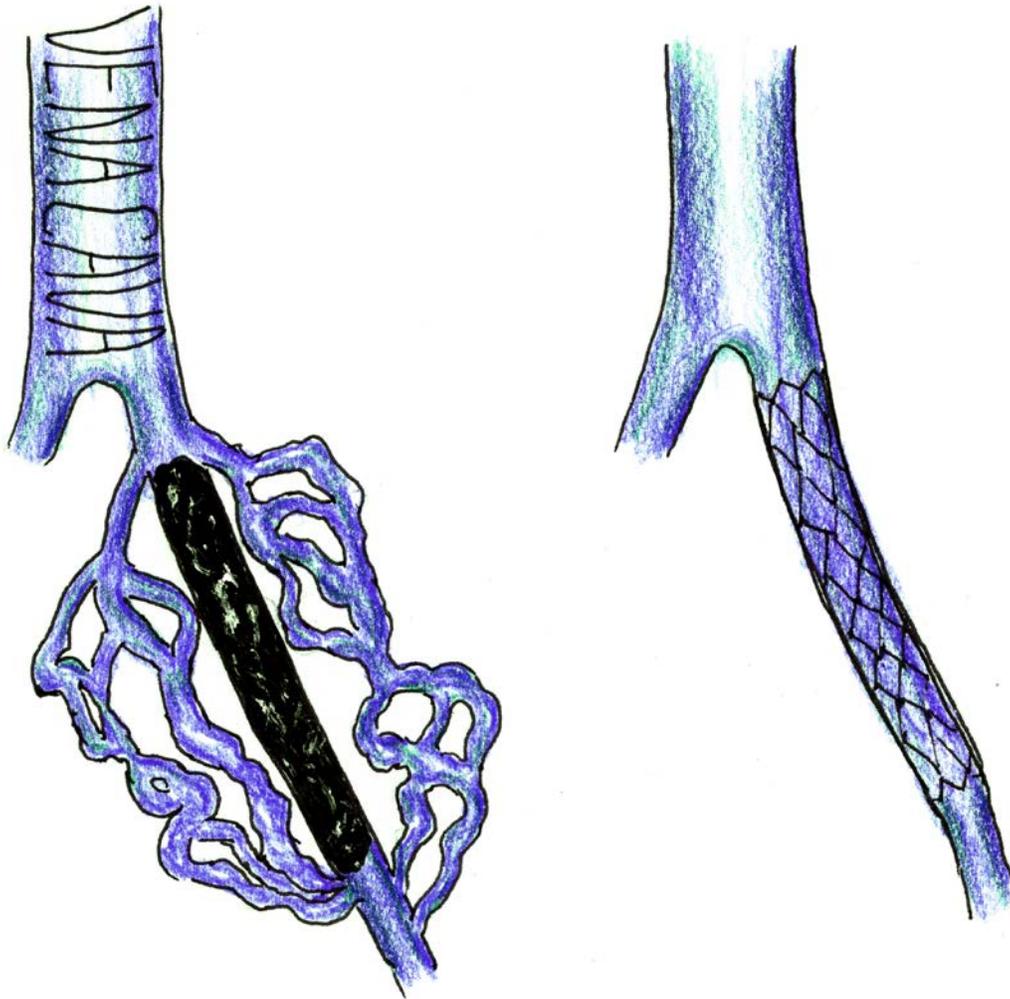
Figure 1: The first picture shows an iliac vein occlusion with many collateral veins (smaller veins going around the blockage) present to help decrease the pressure in the lower as a result of the blockage. The second picture shows a metal stent in the iliac veins which has opened it fully so the collateral veins are no longer seen because the blood is going through the larger and more functional iliac vein. The excess vein pressure in the lower leg has been corrected.

Stents commonly placed in the **iliac vein** are made of one of two metals; either stainless steel or a nickel titanium alloy. The **stents** are “**self expanding**” which means that they open up automatically as they come out of the device (constraining sheath) that gets the stent to the right place in your **vein**. The **stents** are made for large vessel sized (diameters) and open, sometimes with the help of a **balloon dilation**, to go to twelve to fourteen millimeters in diameter (about the size of a quarter). They can be gotten to the **pelvic veins** by placing a needle in a more easily punctured leg **vein** in the groin or behind the knee **vein** (**femoral** or **popliteal vein**) and then pushing the **stent** which is held in a plastic covering on a long wire to the proper place. Once the plastic covering is pulled back and the **stent** opens in the vein, the delivery wire is taken out and gentle pressure of the needle stick stops any bleeding. The **venous system** is a low pressure blood containing tube and so there is rarely a bleeding problem. Many of these procedures can be done in an outpatient setting.
